MERRIMACK RIVER BASIN
FITCHBURG, MASSACHUSETTS

OVERLOOK RESERVOIR DAM AND DIKE

PHASE I INSPECTION REPORT NATIONAL DAM INSPECTION PROGRAM

AUGUST 1980

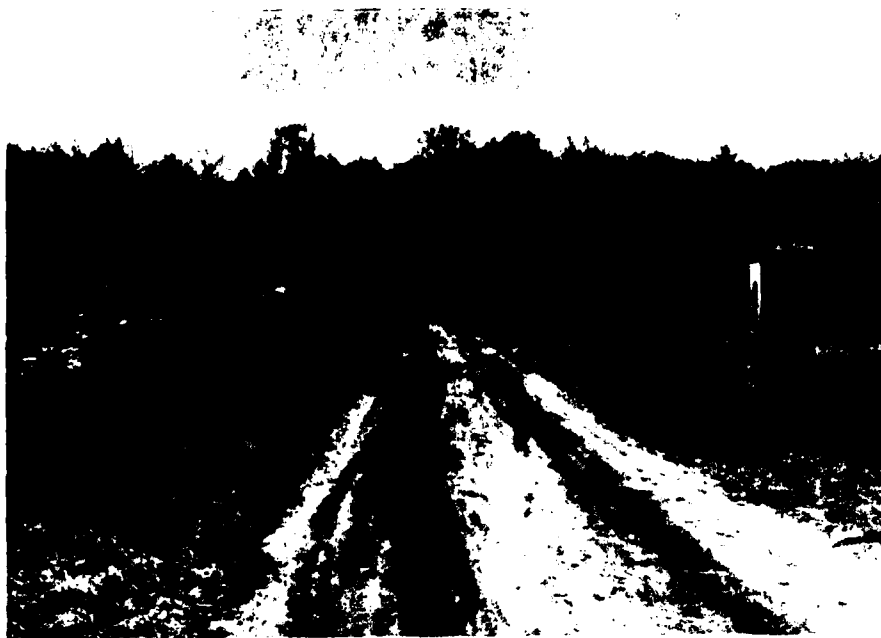
The crest of the dam is approximately 20 feet wide. As shown in photograph 5, a sand and gravel roadway crosses the crest of the dam. No cracking or misalignment is evident.

PHOTO NO. 5 View of crest and gatehouse from the left abutment.

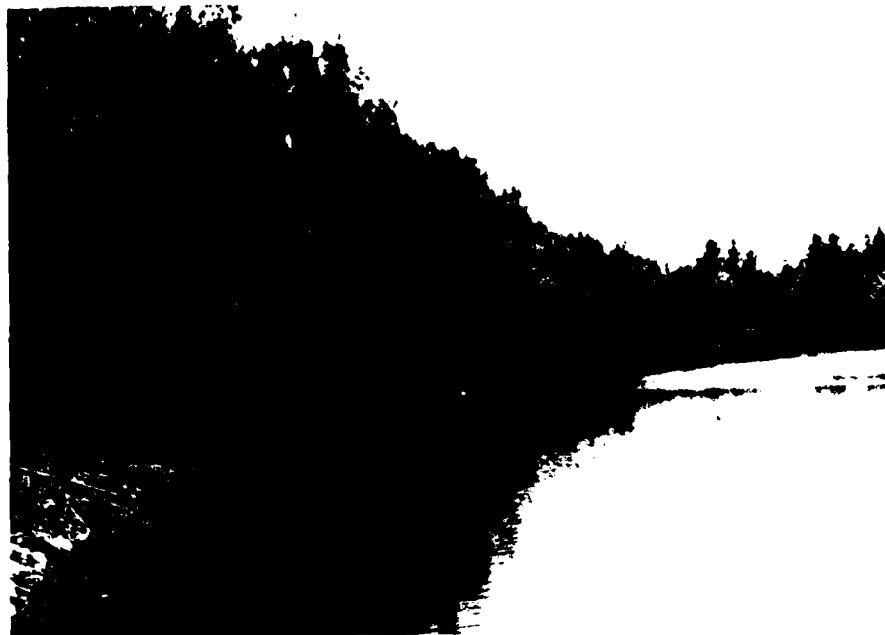
Photo 20 shows the upstream slope from the right abutment to the point of dike curvature and Photo 17 shows the slope from the spillway to the point of curvature. The upstream slope is inclined at 2.5H:1V. The riprap on the slope is in good condition. There is no riprap on the upper 4 feet (measured vertically) of the slope.

Photo No. 17 Upstream slope of dike viewed from spillway toward point of curvature.

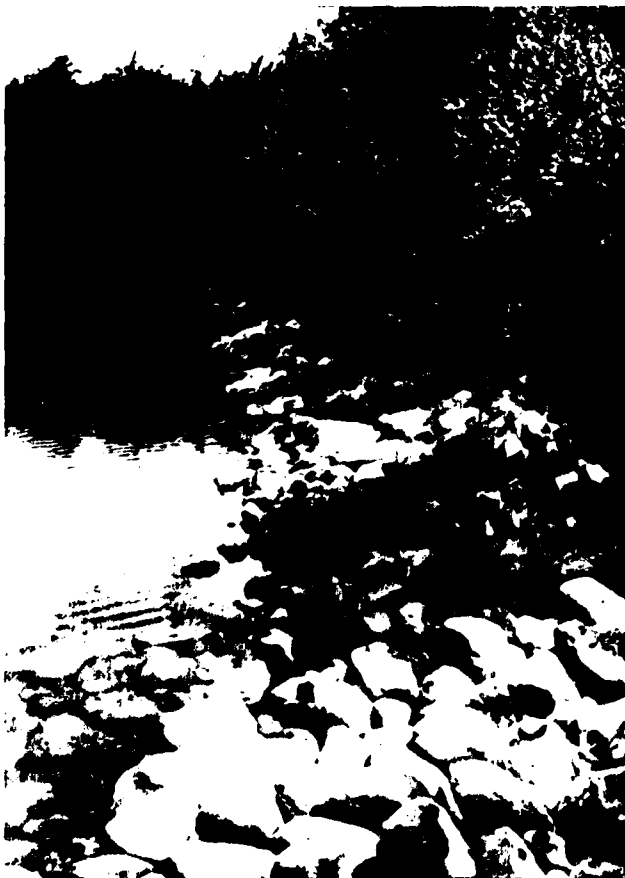
Photo No. 20 Riprap on upstream face from right abutment toward point of curvature.
